#PI0961C: SERVICE HIGH VOLTAGE CHARGING SYSTEM Message Displayed on Driver Information Center (DIC), Hybrid/EV Charging System Disabled, DTCs Set, Revised HV Battery Surge Tank Coolant Fill Level - (Jan 14, 2014)

Models: 2011-2014 Chevrolet Volt

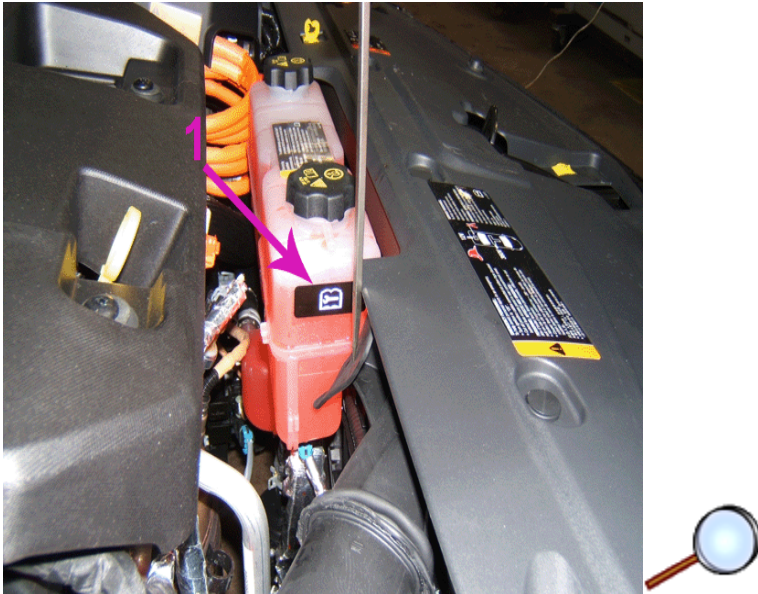
5. Visually inspect the coolant level in the HV battery surge tank and verify that the coolant level is *at the top of the label (1) on the side of the surge tank.*

- *If the HV battery surge tank coolant level is not at the top of the label (1) on the side of the surge tank, Go to the section titled: Pressure Test Procedure in this Diagnostic.*

- *If the HV battery surge tank coolant level is at the top of the label (1) on the side of the surge tank, Go to Step 6.*
6. Remove the front compartment front sight shield. Refer to Front Compartment Front Sight Shield Replacement in SI.

16. Upon completion of the Hybrid/EV battery pack coolant pump bleed procedure, *adjust* the surge tank coolant level to the *top of the label (1)*, by performing this procedure, — Drive Motor Battery Cooling System Draining and Filling — Removing Excess Coolant From System in SI.
